4. TITLE (and Subtitle) WILLOW CREEK DAM SPILLWAY AND STILLING BASIN AT HEPPNER, OREGON Hydraulic Model Investigation		5. TYPE OF REPORT & PERIOD COVERED

WILLOW CREEK DAM
SPILLWAY AND STILLING BASIN
AT
HEPPNER, OREGON

Hydraulic Model Investigations

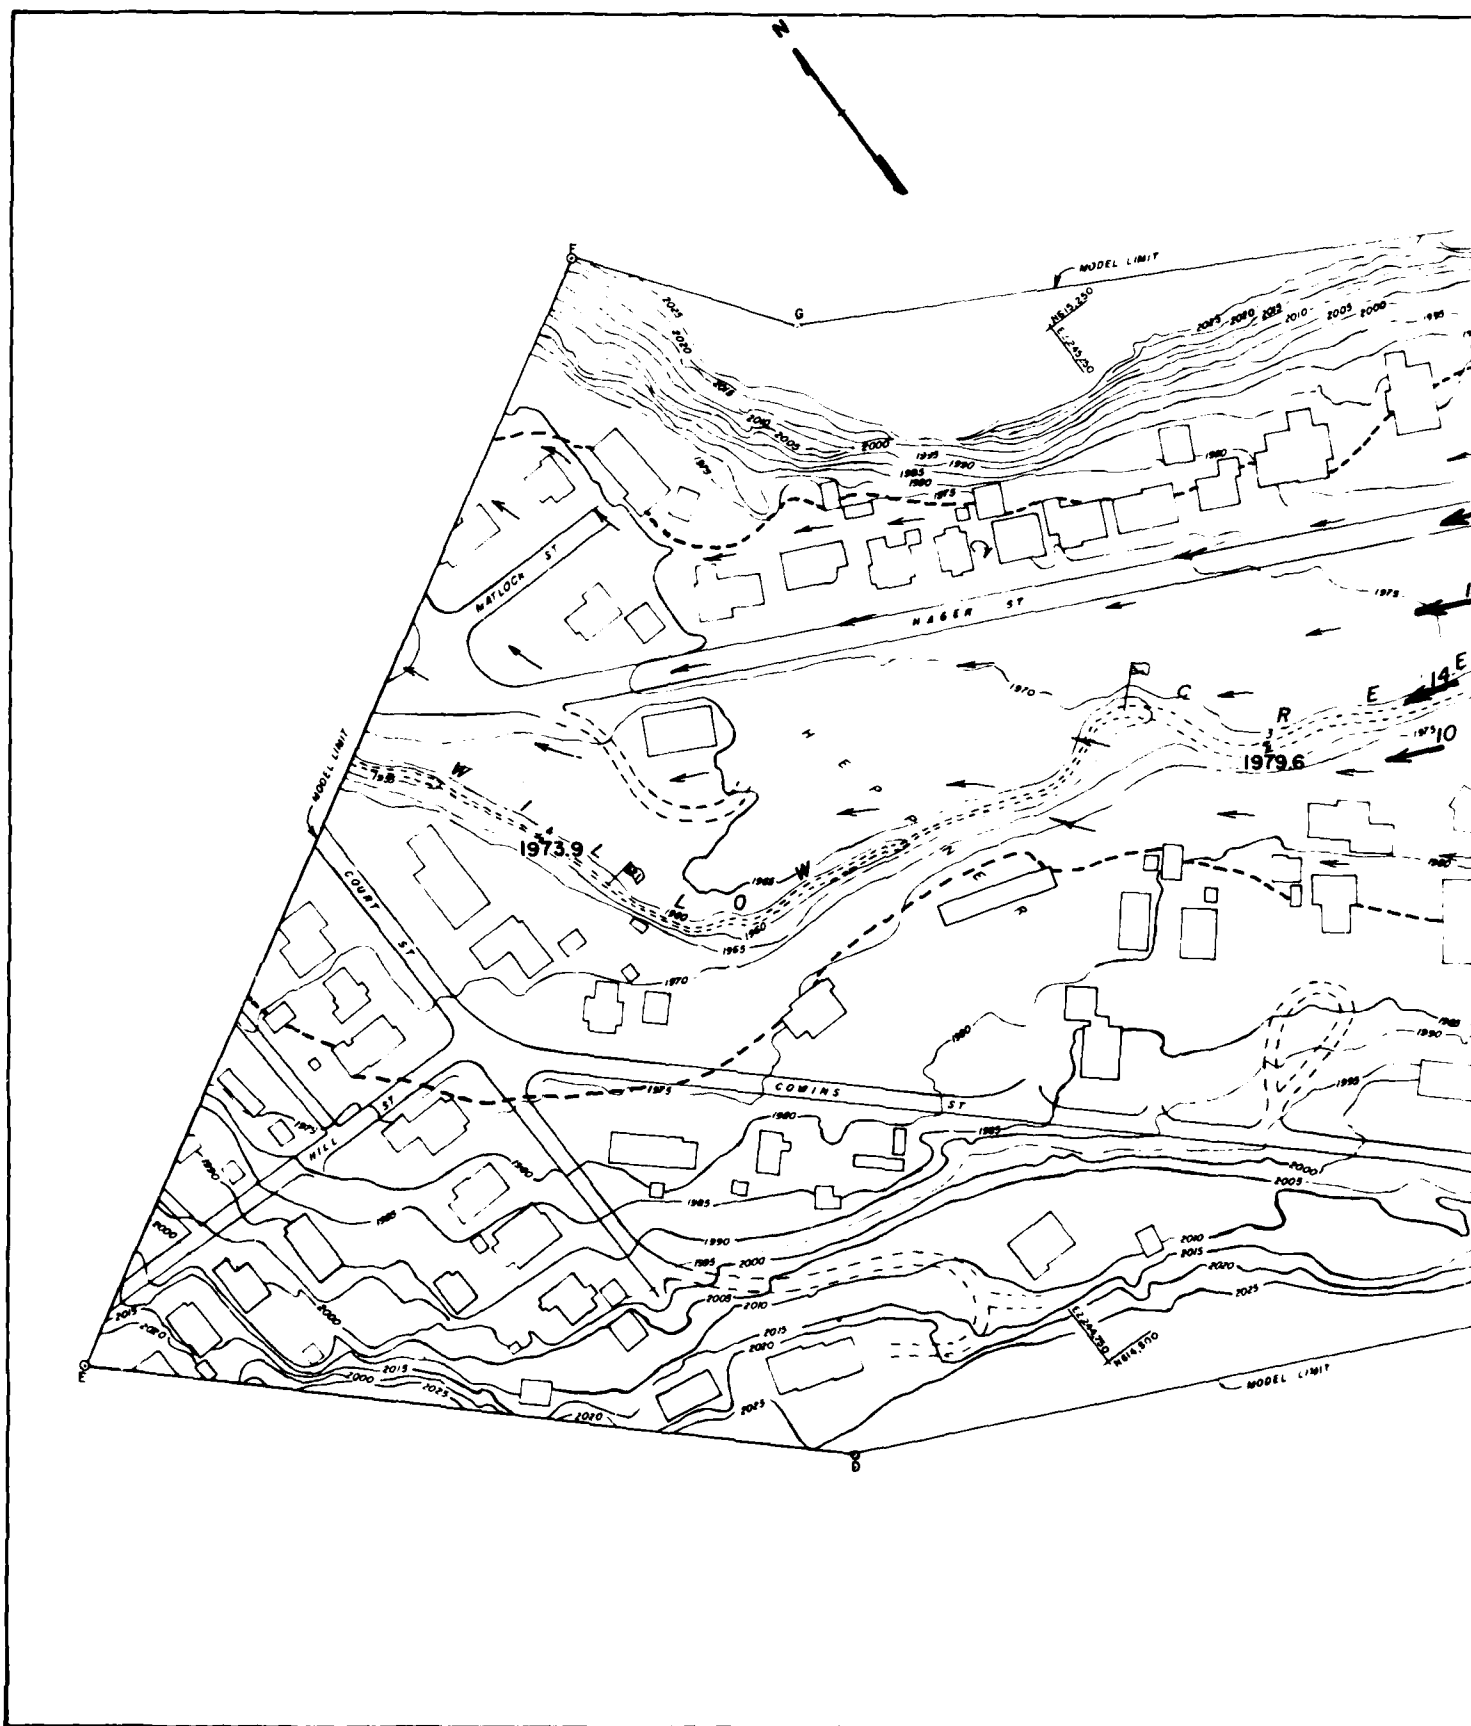
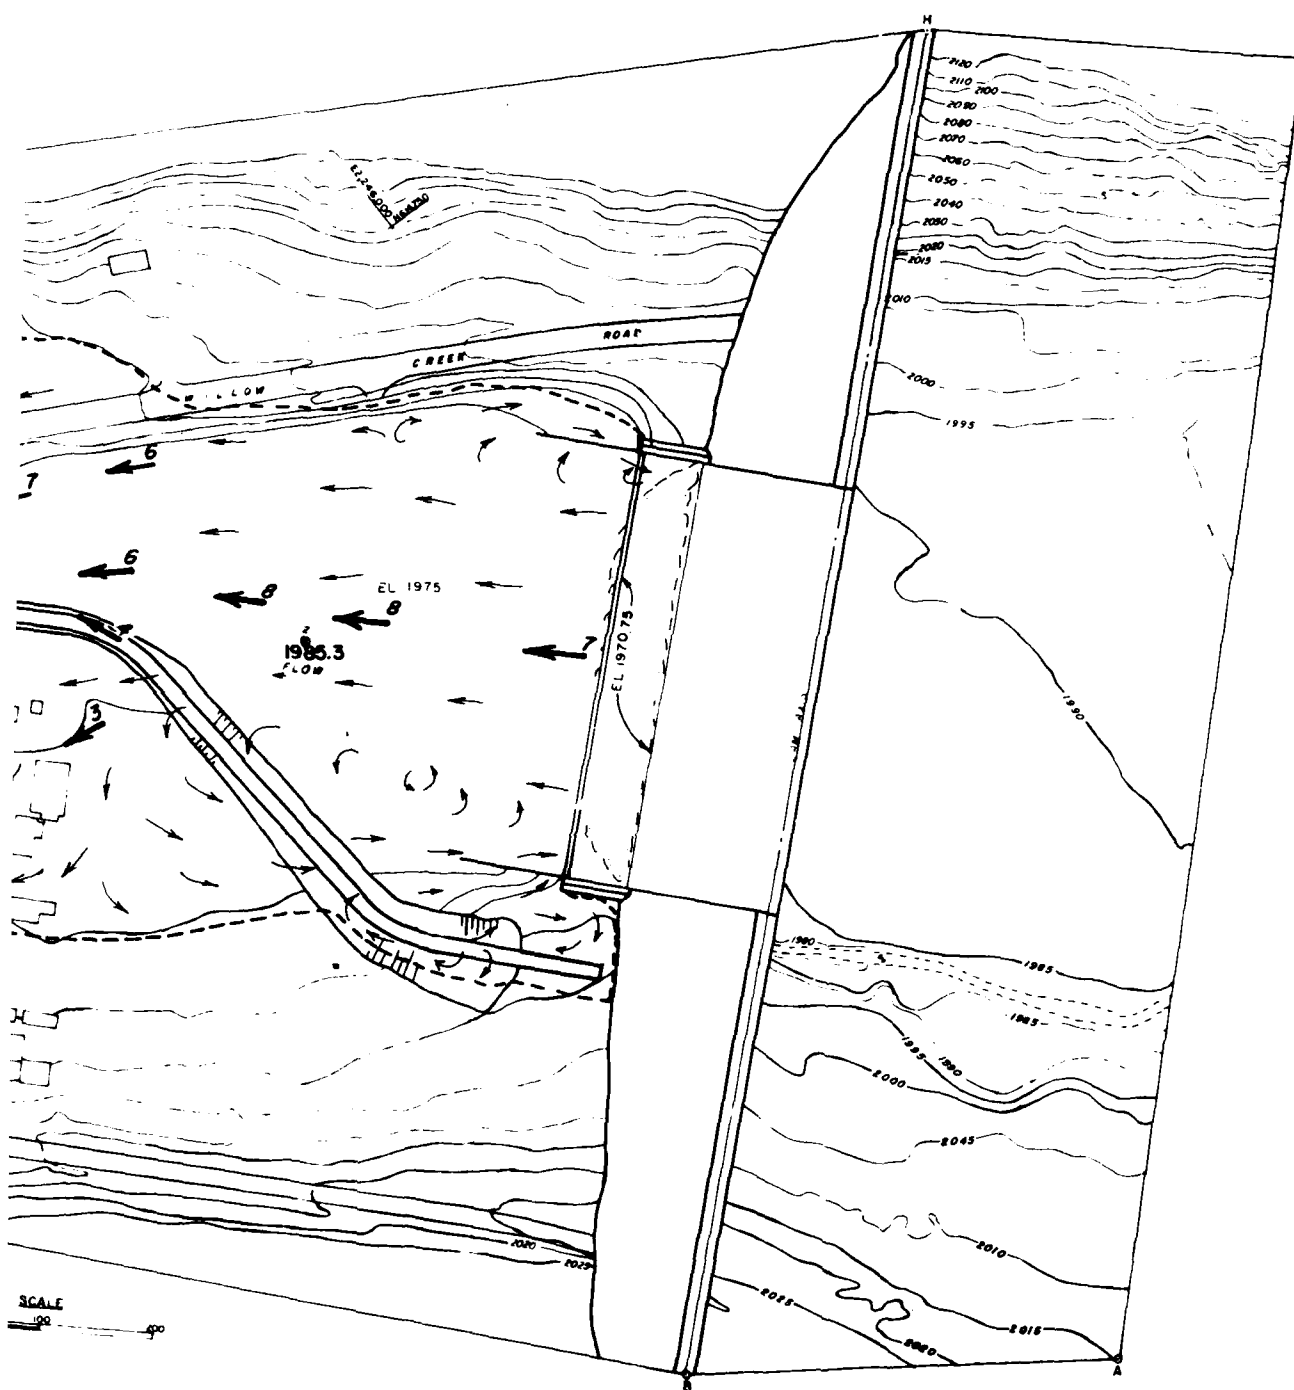
FLOW CONDITIONS

DISCHARGE 18 000 CFS

STILLING BASIN FOR 18000 CFS WITH SCOUR

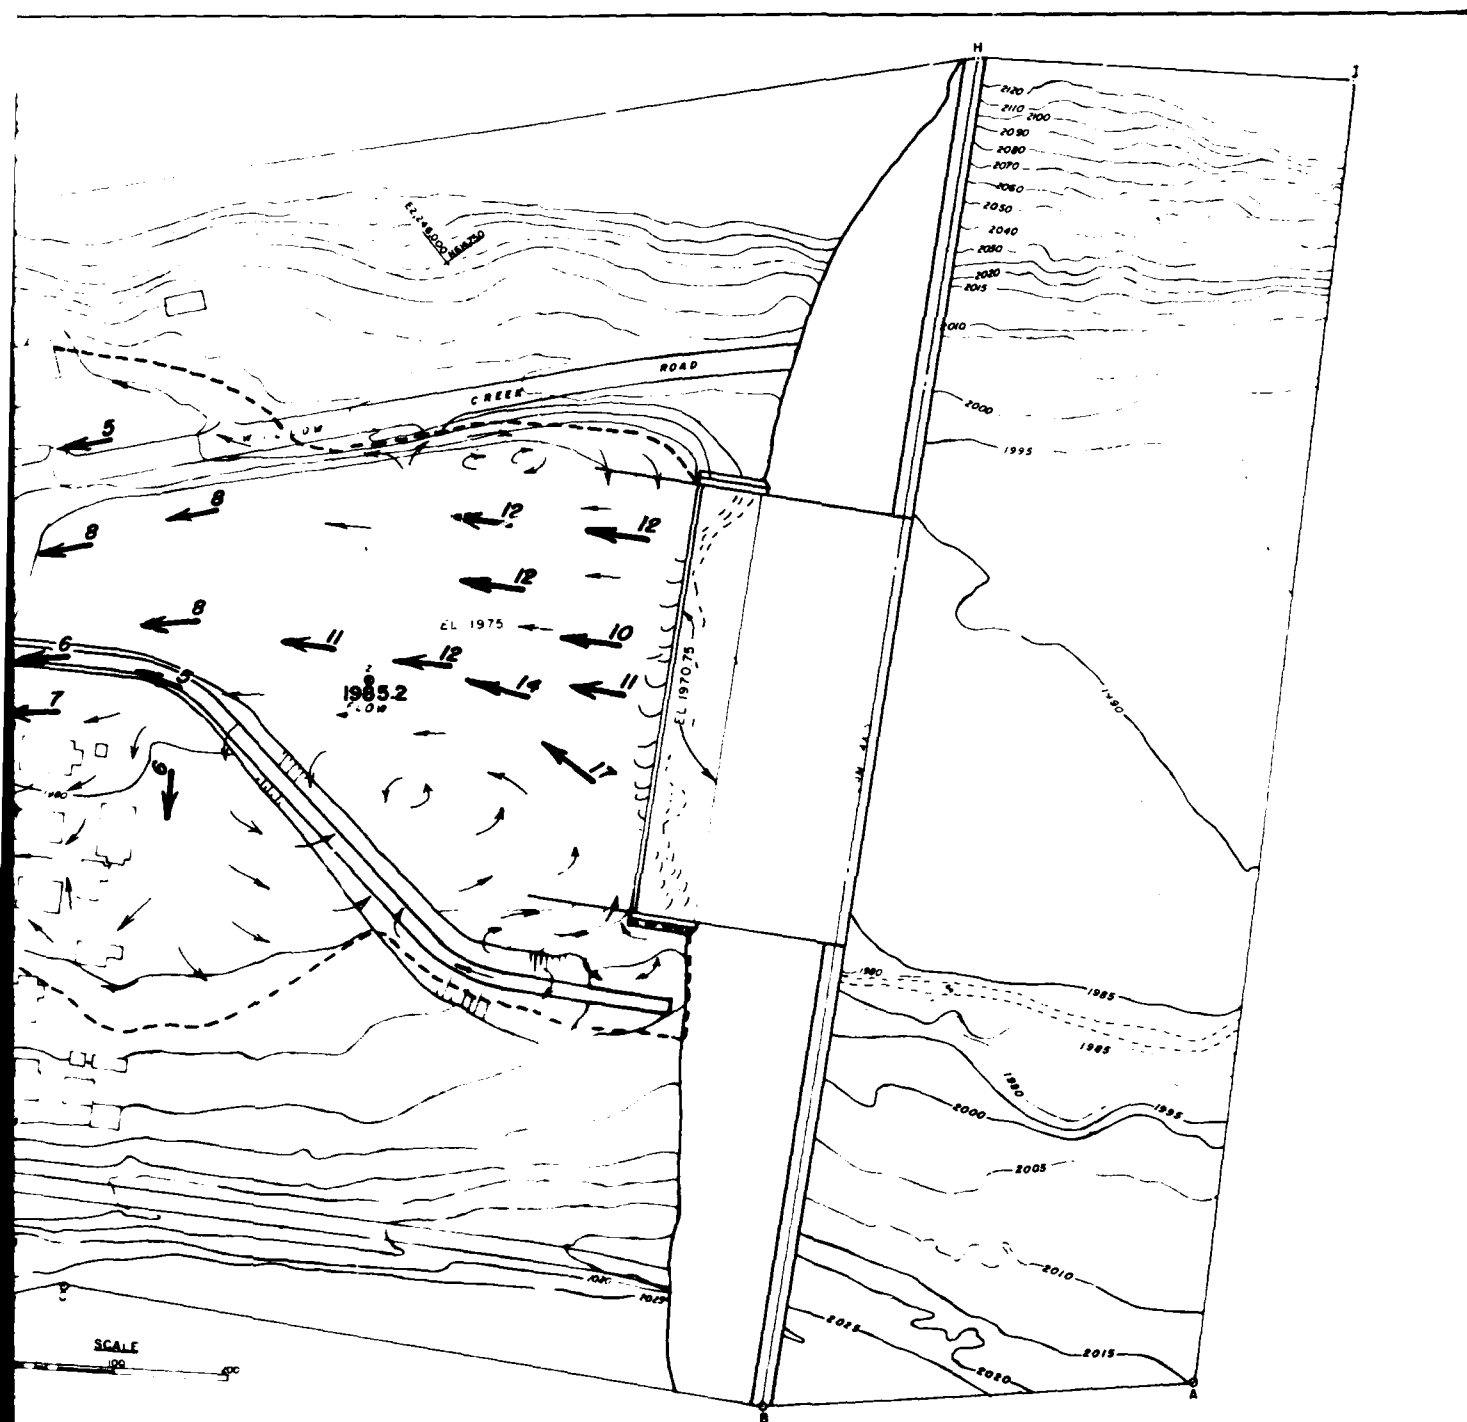
PLATE 10

FLOW CONDITIONS
 BASIN SWEEPOUT
 DISCHARGE 24 000 CFS

STILLING BASIN FOR 18000 CFS WITH SCOUR

area just downstream from the basin, 6 fps at Alfalfa Street bridge, and 12 and 14 fps 100 feet farther downstream (plates 8 and 9). With a discharge of 24,000 cfs, the jump began to sweep from the basin (photograph 19). Velocities in the simulated scoured area were as high as 17 fps. Velocities were 6 fps at the bridge and 14 fps 100 feet downstream (plate 10). With 45,000 cfs, velocities were 37 fps downstream from the sweepout, 12 fps at the bridge, and 18 fps 100 feet downstream (photographs 20 and 21 and plate 11). With the spillway design flood of 91,700 cfs, velocities were 48 fps downstream from the sweepout, 26 fps at the bridge, and 36 fps about 100 feet downstream (photographs 22 and 23 and plate 12). Flooding conditions with the regulated thunderstorm SPF and the SDF are shown in photographs 24 and 25.

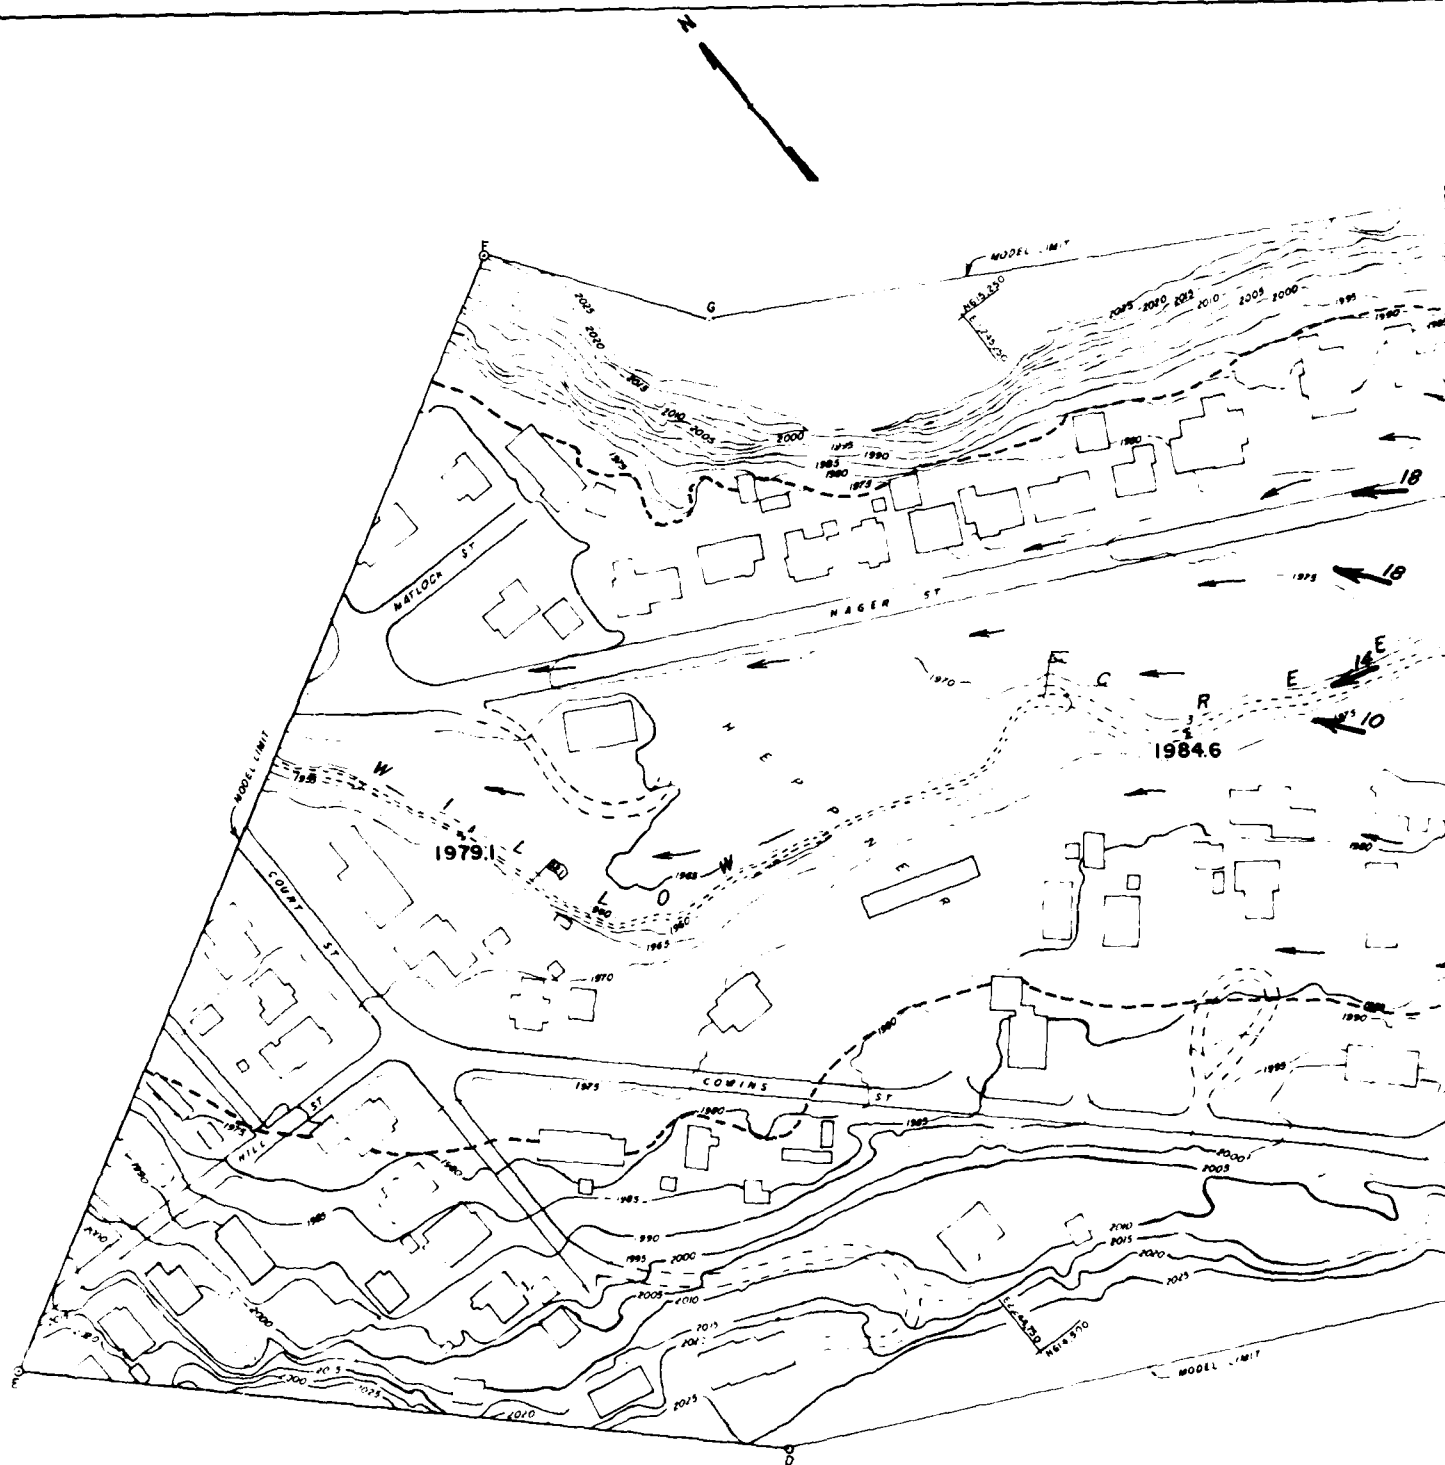
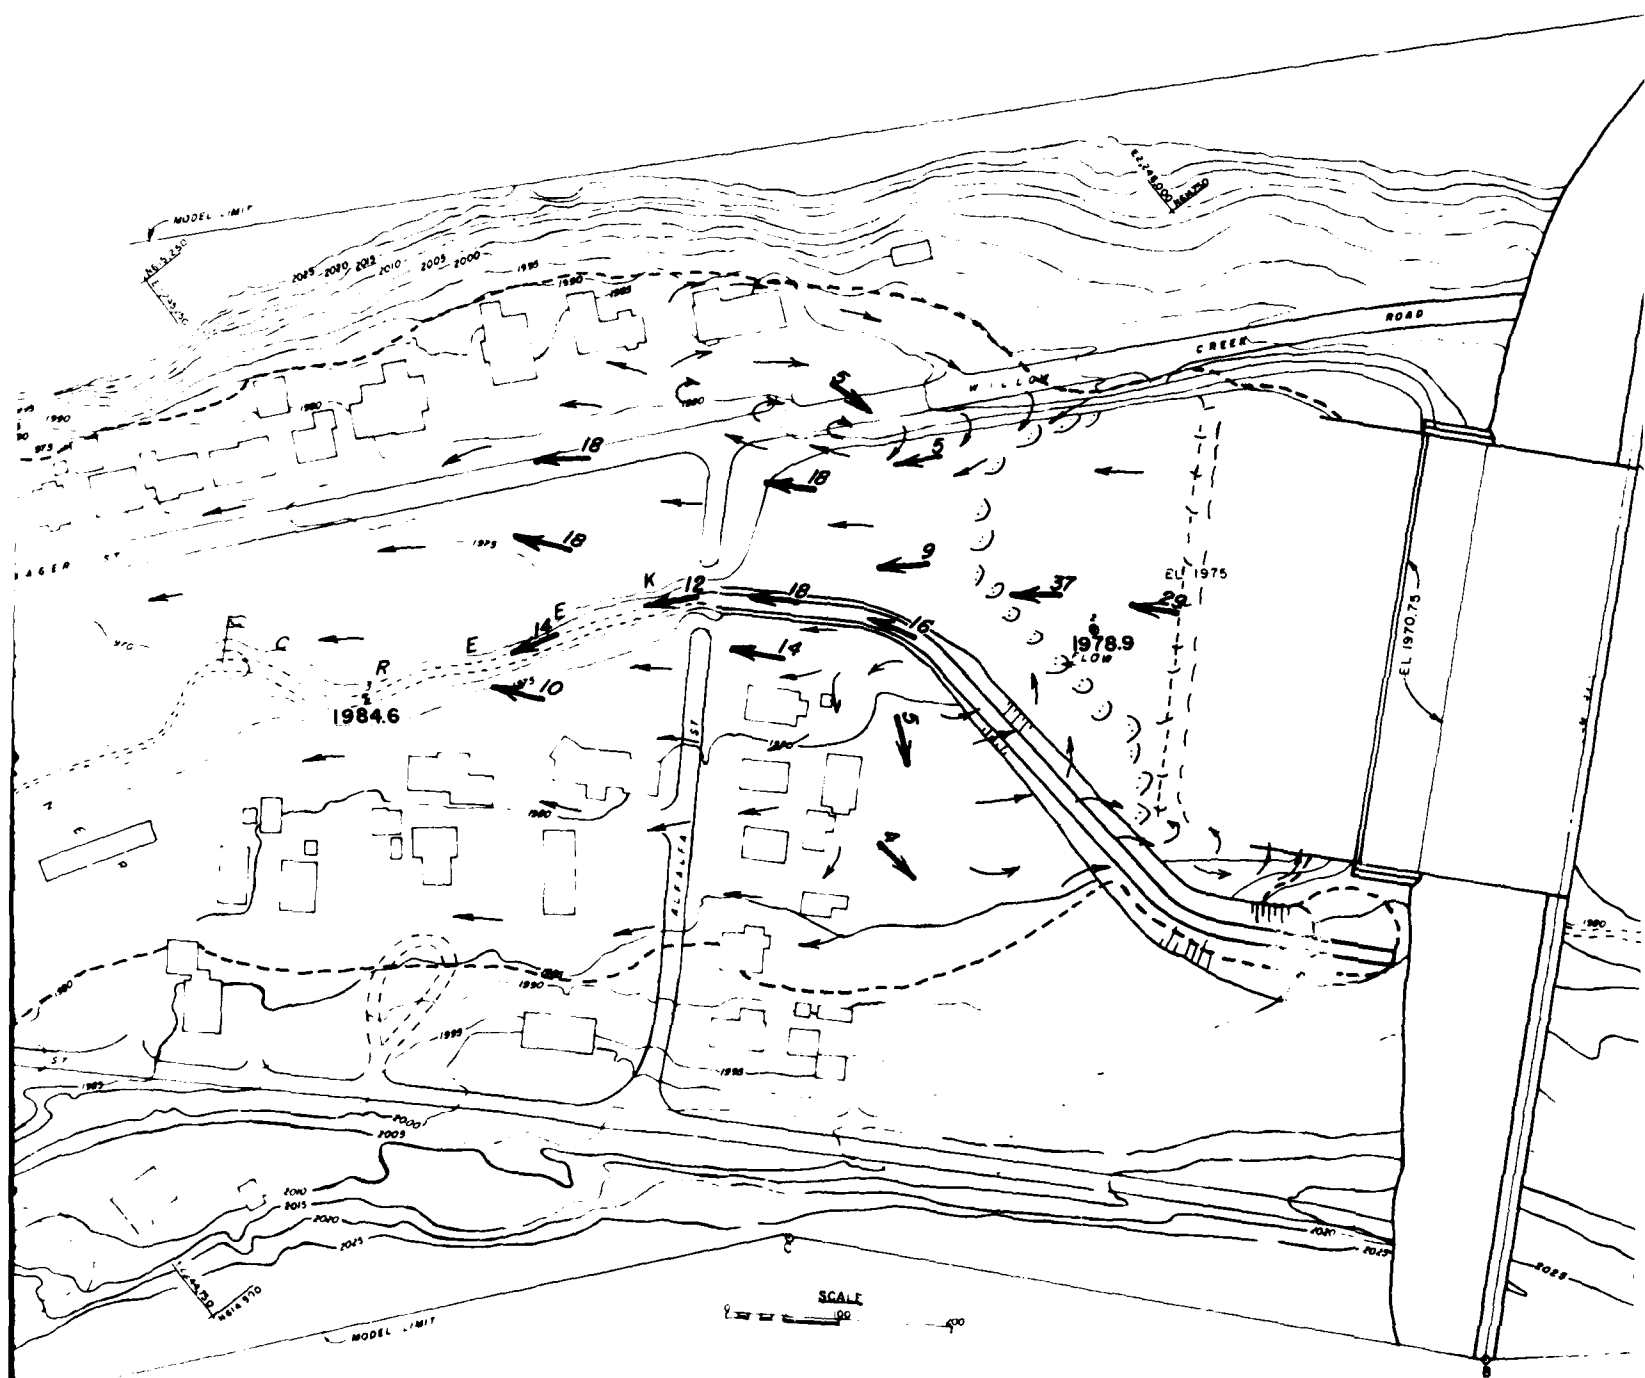
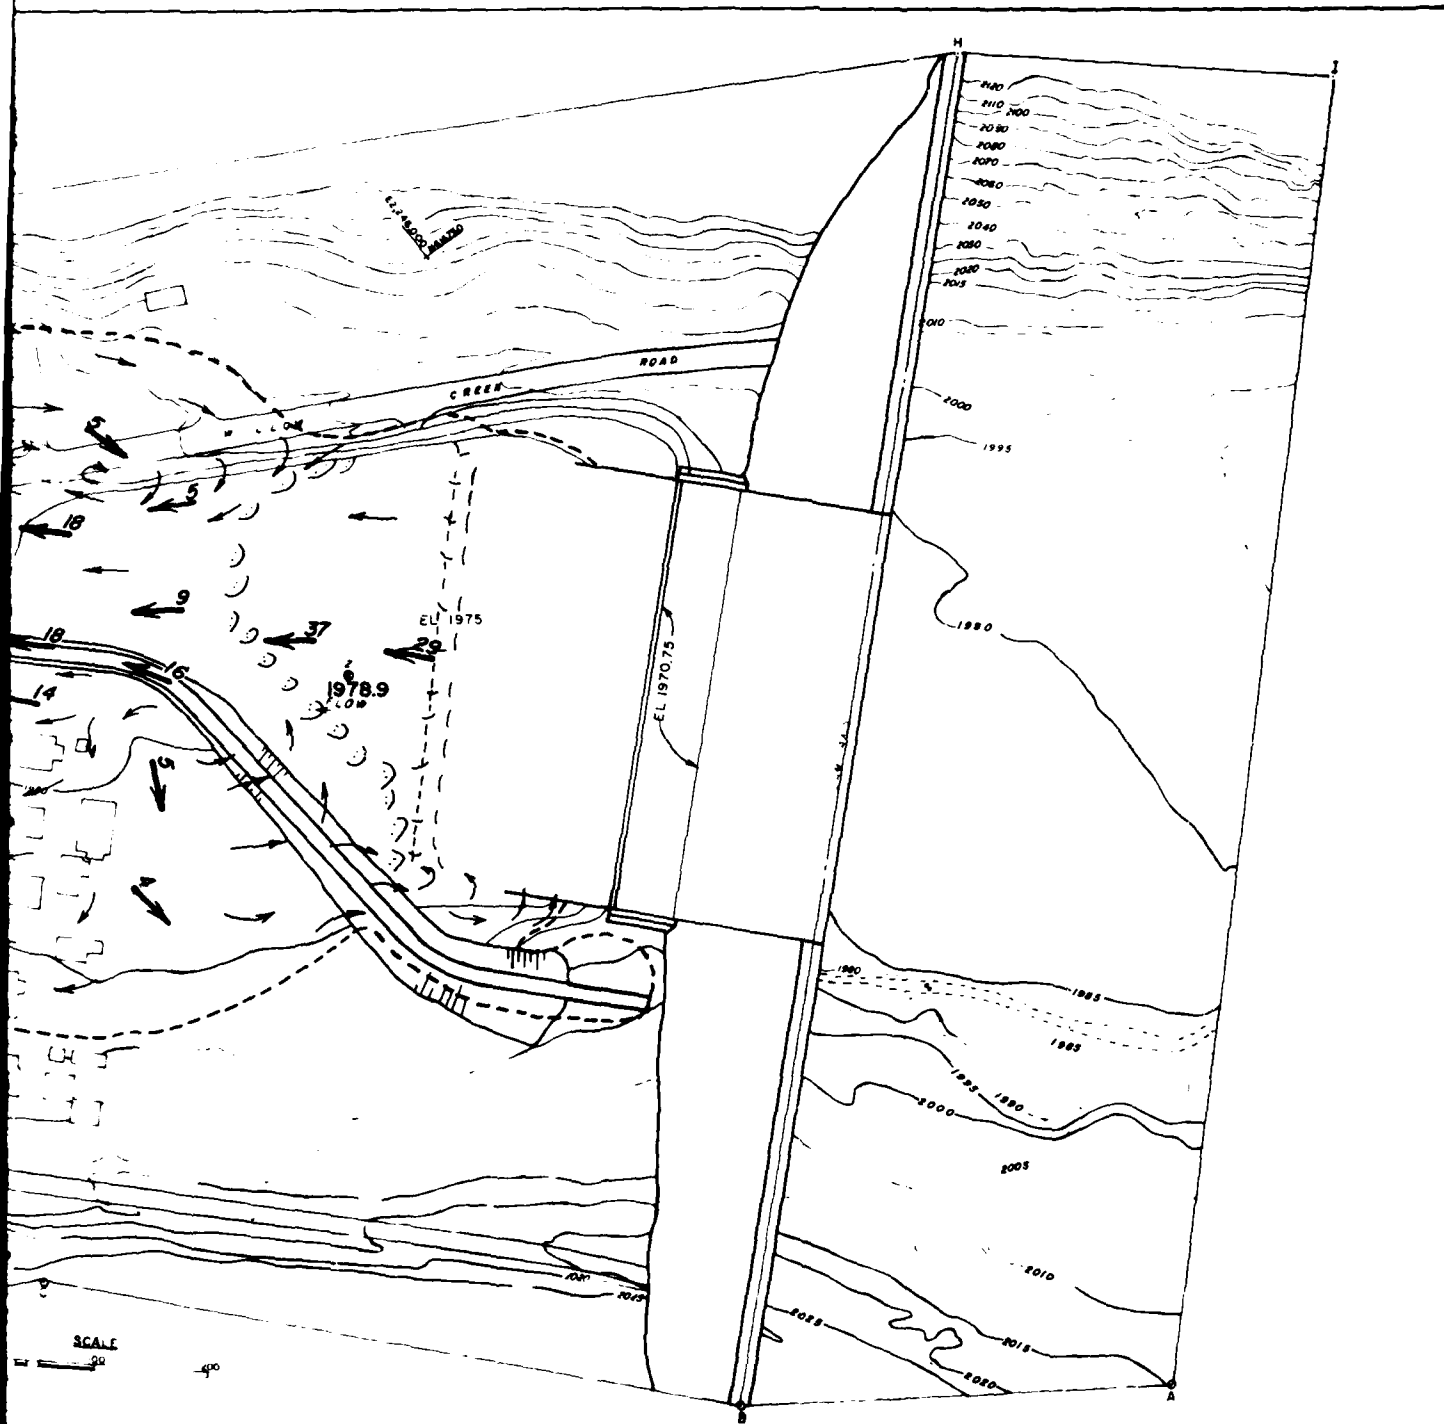
FLOW CONDITIONS

DISCHARGE 45 000 CFS

STILLING BASIN FOR 18 000 CFS WITH SCOUR

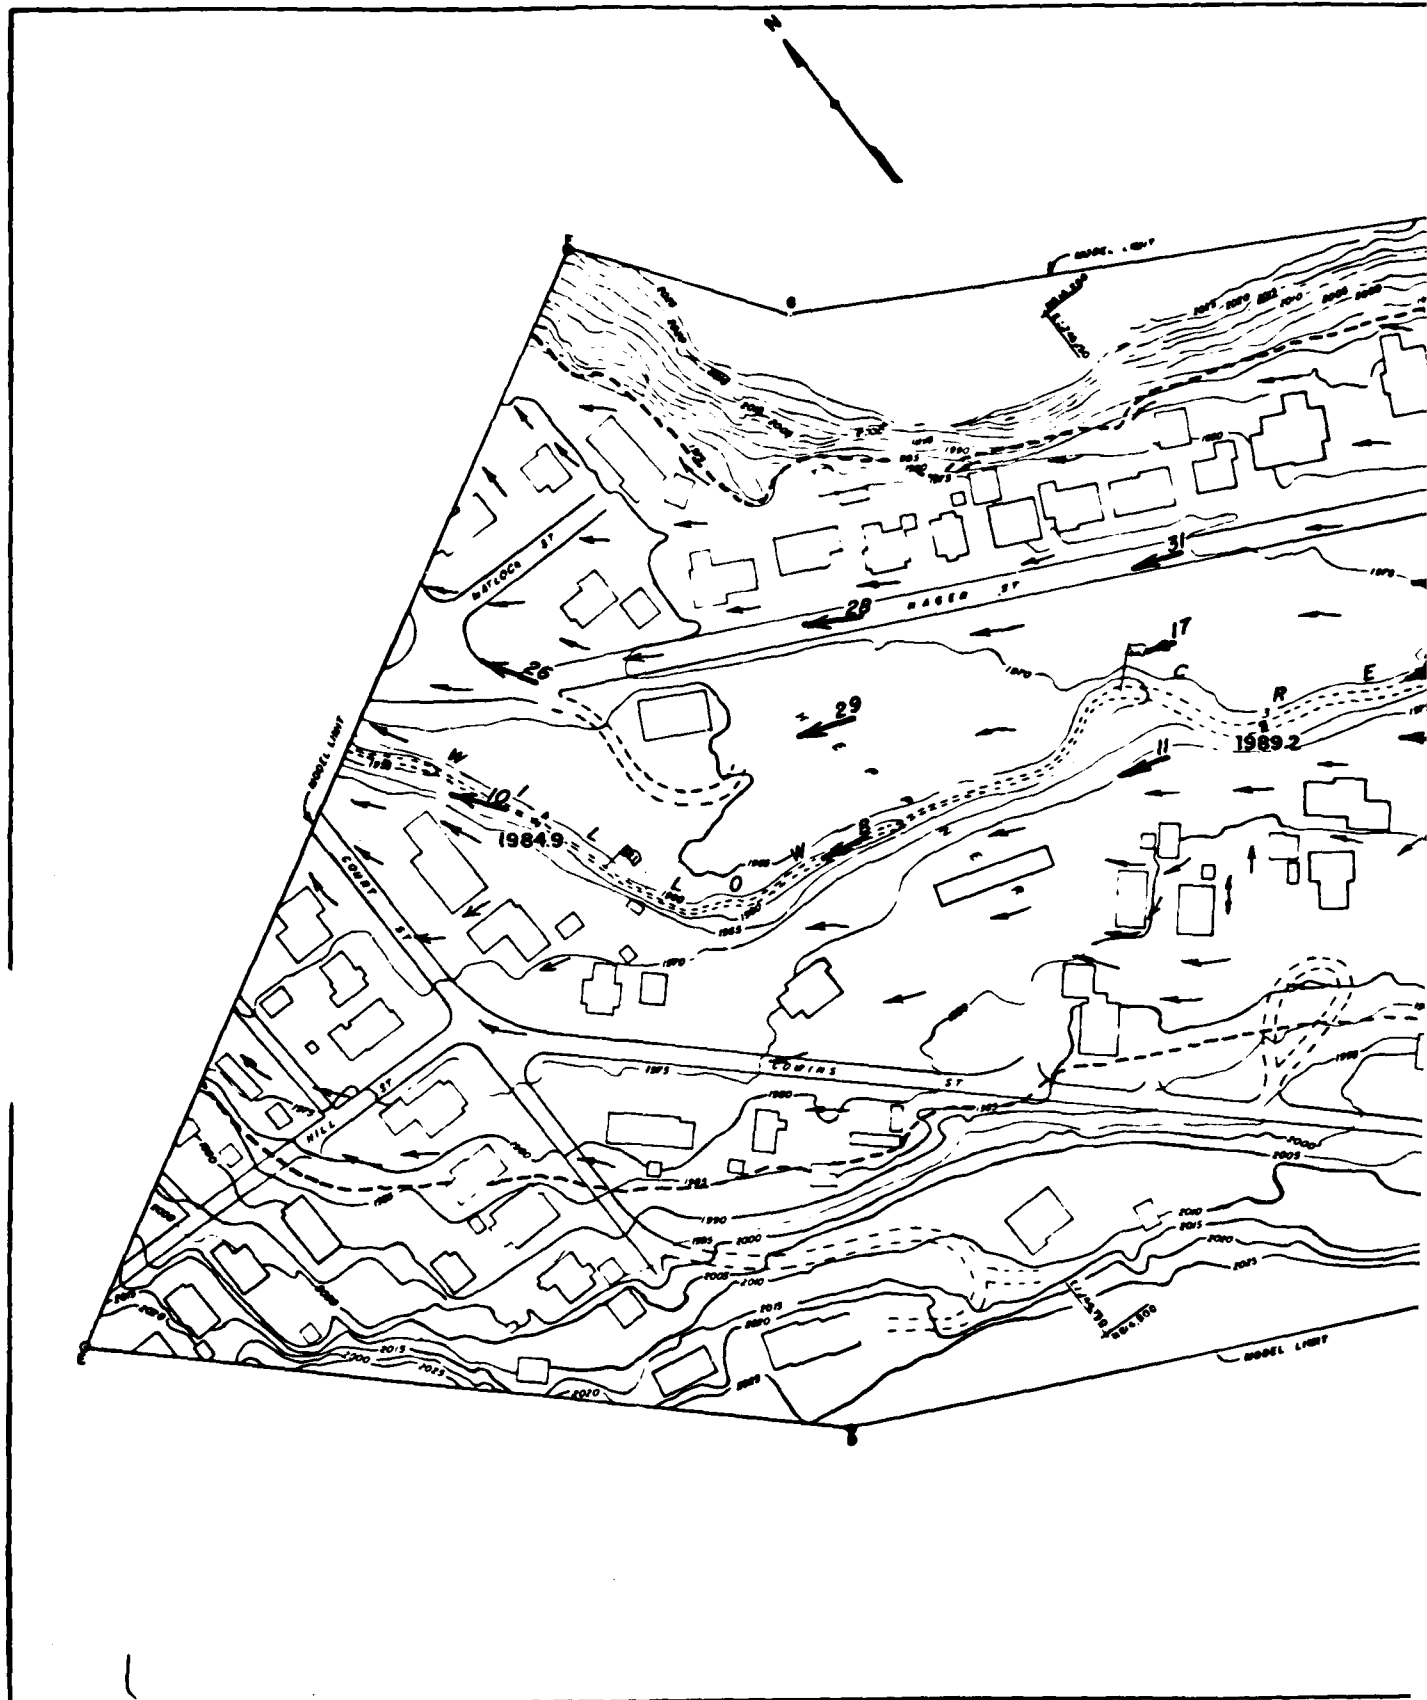
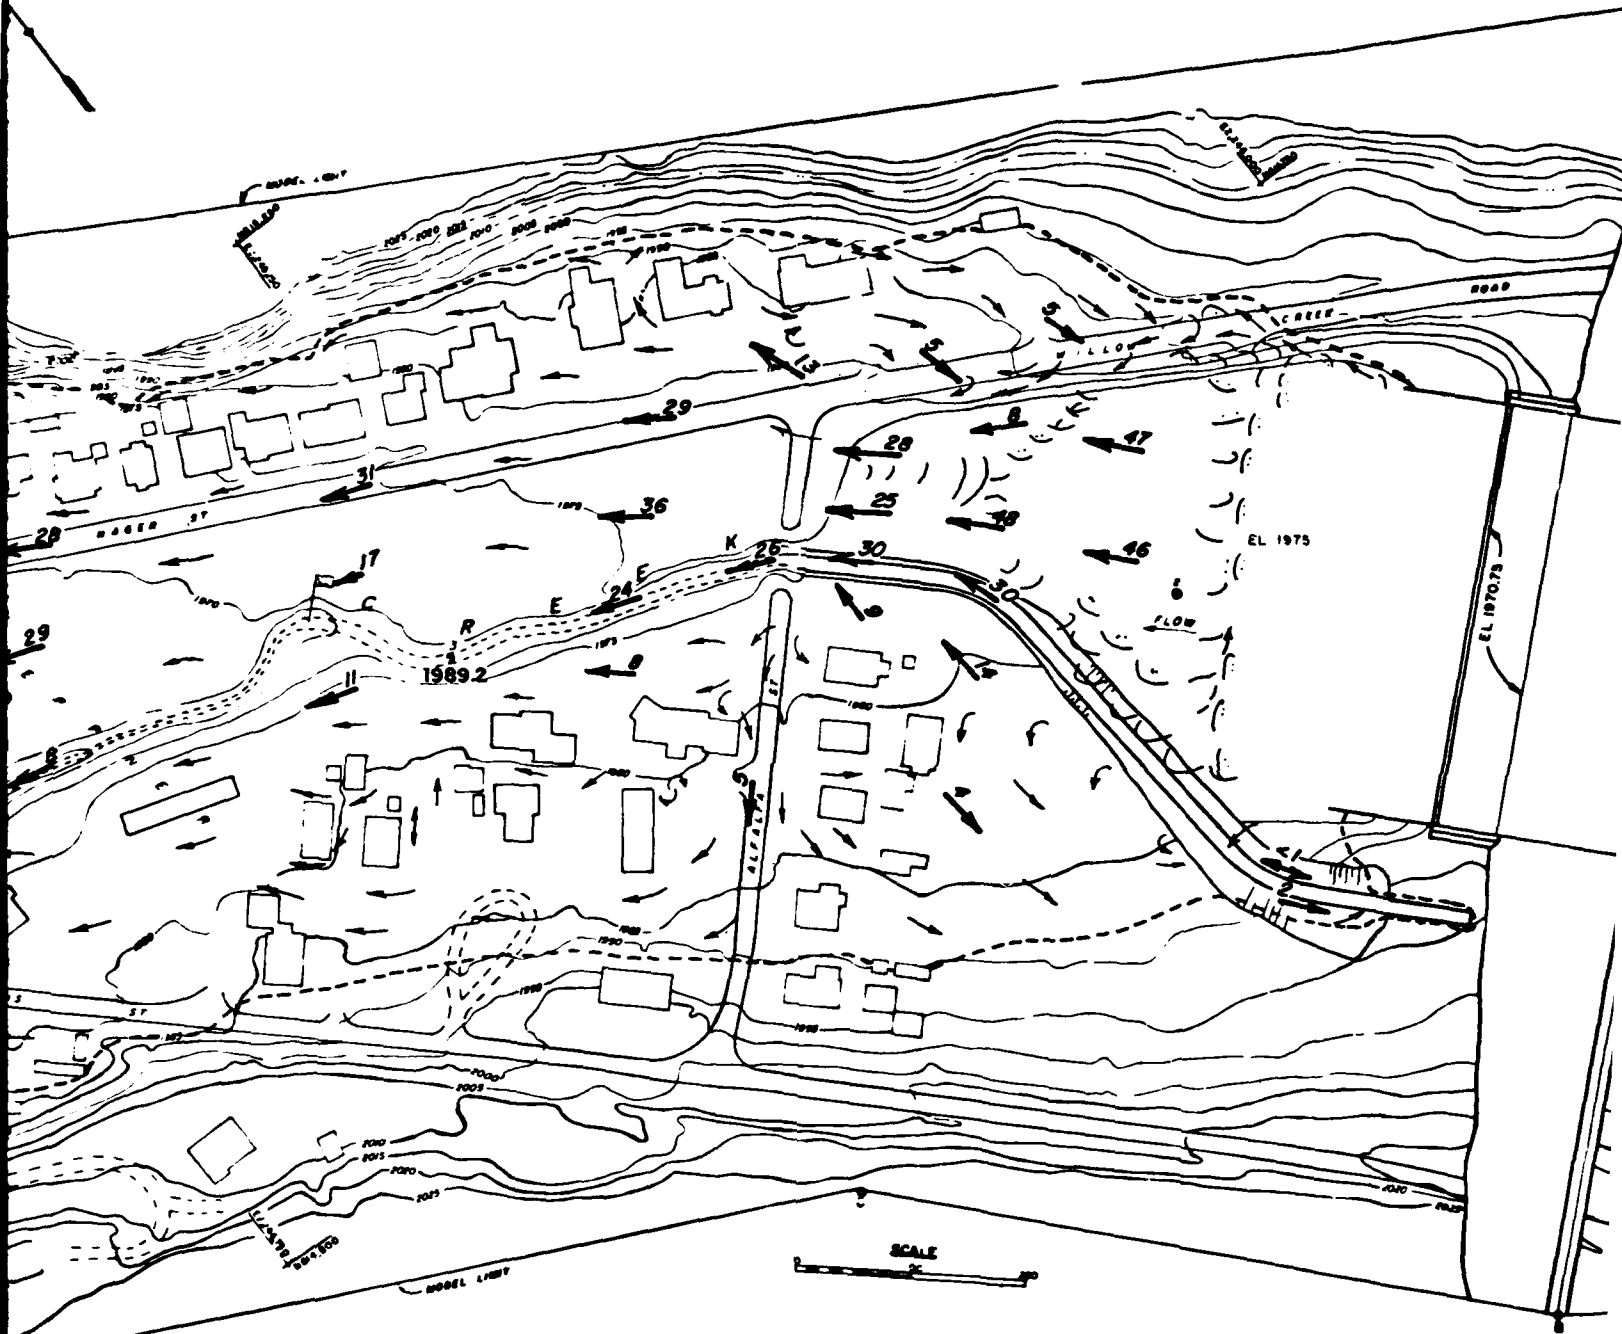
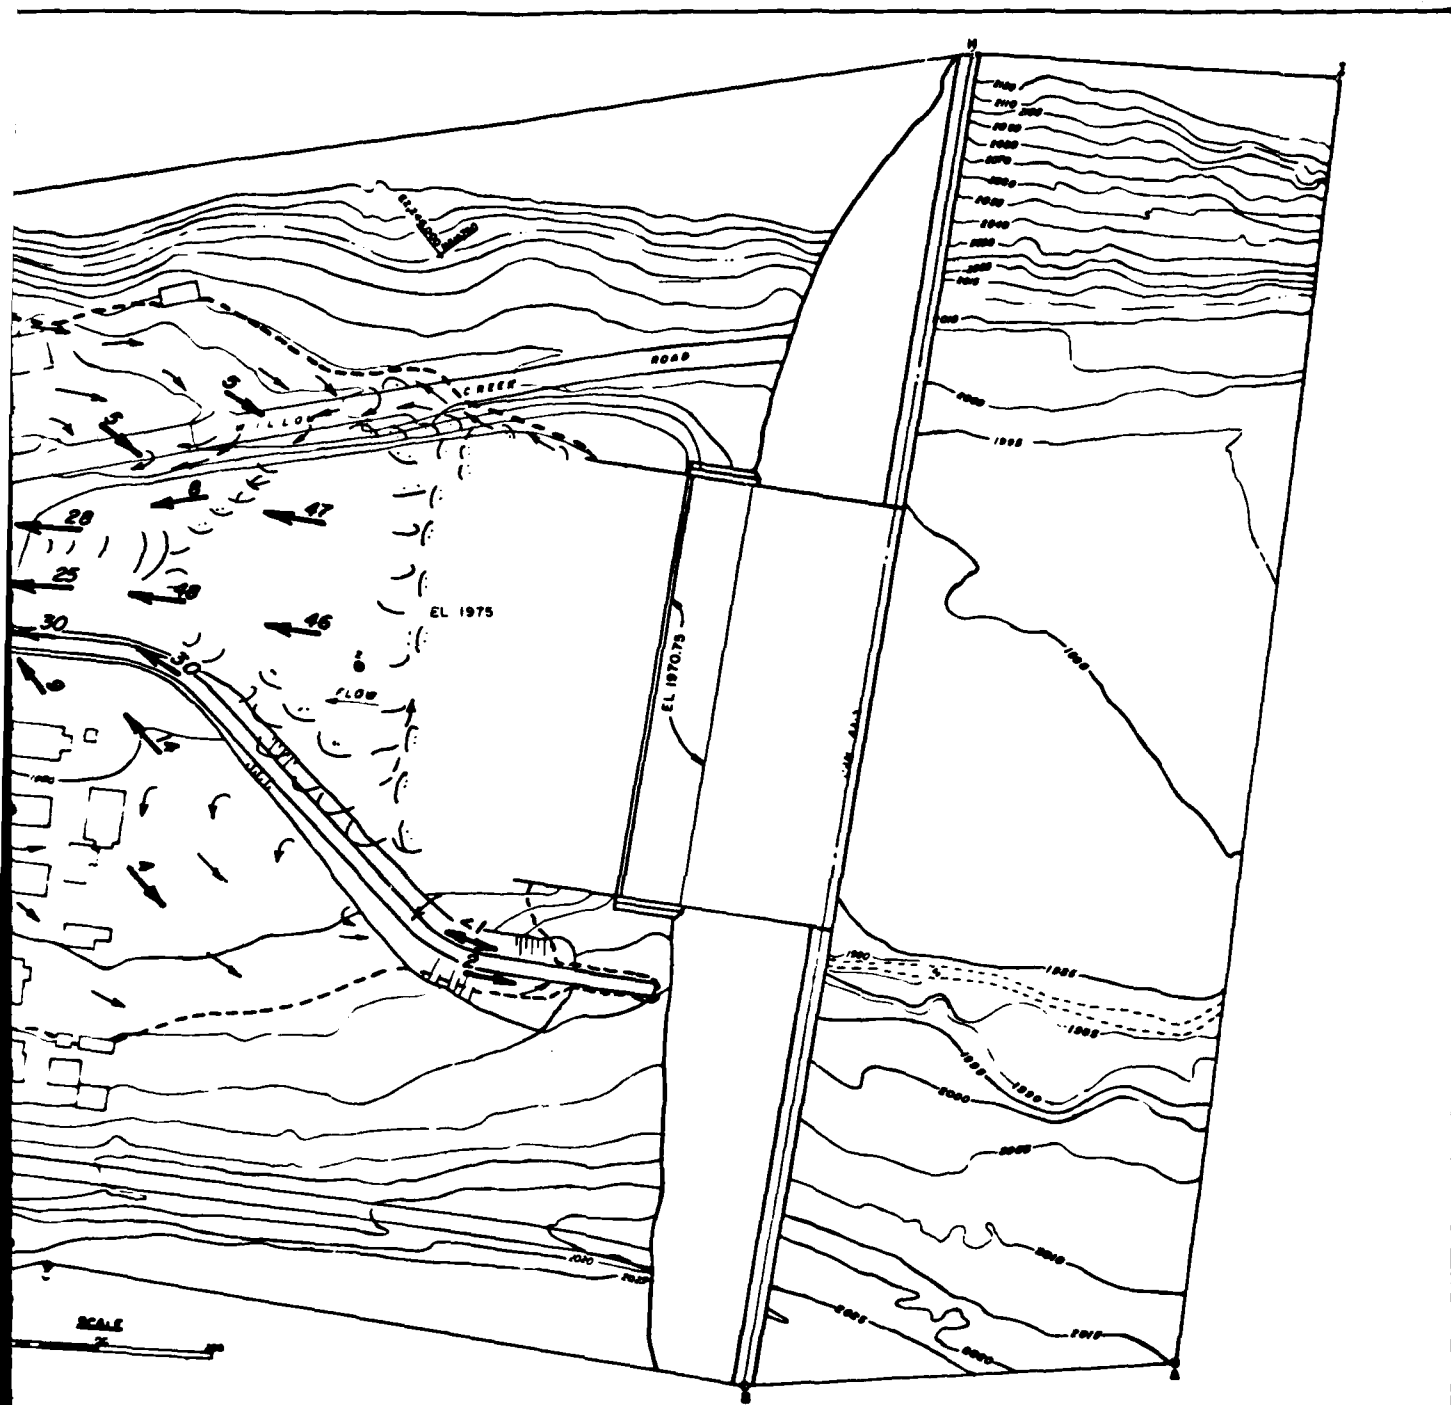
FLOW CONDITIONS
REGULATED SPILLWAY DESIGN FLOOD
 DISCHARGE 91 700 CFS
 STILLING BASIN FOR 18000 CFS WITH SCOUR
